## Architectural Investigation and Material Characterization of Byzantine Brick Masonry Church: A Case Study of the Üç Ayak Church

Merve Başgül <sup>1</sup>

& Şerife Özata <sup>2</sup>

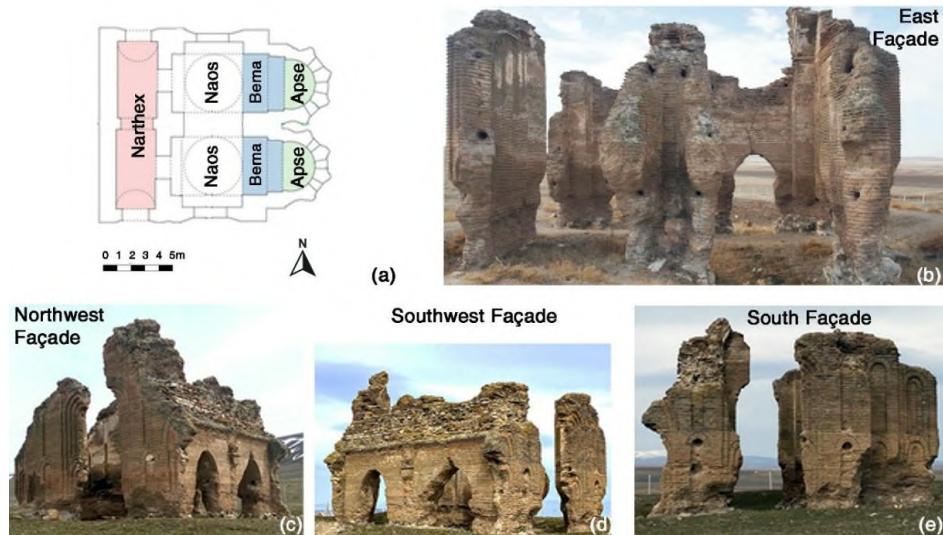
**Figure 4:** Figure 4: (a) Plan of Üç Ayak Church, (b) Current situation of the south facade, ruined apses, (c, d, e) Current condition of the façades

Based on the comparison of the old photographs in (Figure 3) and the up-to-date photo in (Figure 4), it can be deduced that a section of the apse has been missing since the early discovery of the building. It is estimated that there was a semi-dome over the apse. The apse in the plan shared in (Figure 3) drawn by Crowfoot<sup>28</sup> differs from the actual apse discovered during excavations<sup>29</sup>, which has five facades that add dynamism to the building's design.

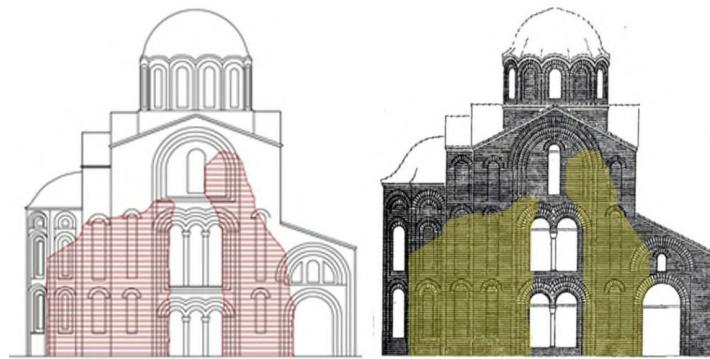
The highest point of the remaining walls, which were constructed without plaster, is 10 m (Figure 5). The style of the narthex walls remains unknown as they have not survived to this day, but the narthex has a single story. Despite the center of the north façade of the church being destroyed, it is clear that there are two different levels of niches on this façade made up of four intertwined arches. The architectural survey depicts that the upper sections of the niches were designed with round arches and double-triple windows set into these niches. The evidence of triple windows was found on the apse façade. Although it is stated that there is a drum in the dome, which is claimed to be about 17 m high<sup>30</sup>, the accuracy of this information is doubtful since the cupolas are generally built without a drum on the pendentive structural elements. If the dome were built using squinches on a square plan, the drum part might have been formed. Based on this information, two different possible restitution drawings of the north façade are presented in (Figure 5). These drawings on the left and the right have been modified from sources published by Eyice in 1968<sup>31</sup> and 2004, respectively, and<sup>32</sup> the remains are shown in (Figure 5).

**Figure 5: Different representative restitutions of the north façade**

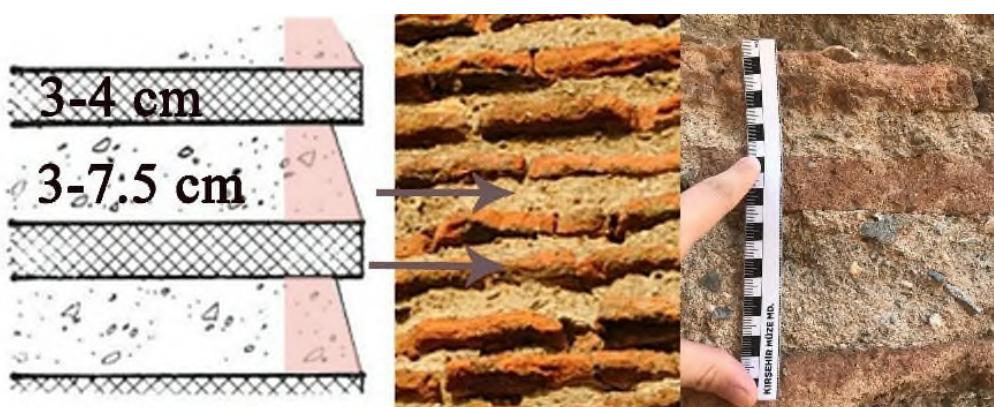
**Figure 6: (a) Structural wall detail of Üç Ayak Church.**

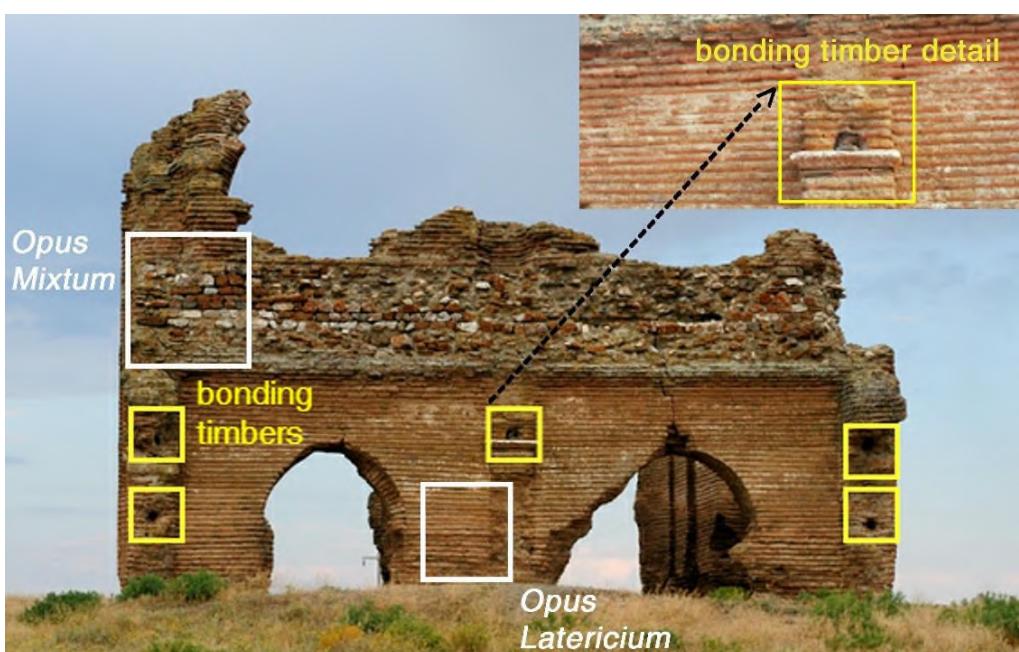
Based on the brick workmanship, it can be said that the walls were built with the *Opus latericum* technique, while the *Opus mixtum* technique, which characterizes hybrid construction, was used throughout the building since there are also stones. The types of brick quality mentioned are marked on the image in (Figure 7).

Upon the 90-cm-thick structural walls, a single circular wooden bond beam measuring 18 cm in diameter is positioned at approximately 380 cm above the ground level, resting atop the designated arches. On the piers measuring approximately 140x170 cm, three square wooden beams, each measuring approximately 18x18 cm, are installed at heights of around 40 cm, 160 cm, and 300 cm, originating from the stone-formed plinth level, which stands at 50 cm high. Some of these bonding beams are shown in (Figure 7). Schweinitz<sup>36</sup> stated that wooden beams placed inside the walls during the construction of the building increase the resistance of the building against earthquakes. This information is partially correct because the bonding timbers used with a certain level of spacing within the brick masonry wall reduce the slenderness and improve the earthquake performance and the stability of the structure.

Figure 7: The bonding timbers in between the masonry brick wall and brick quality samples on the west façade  
Source: Prepared by Ş. Özata

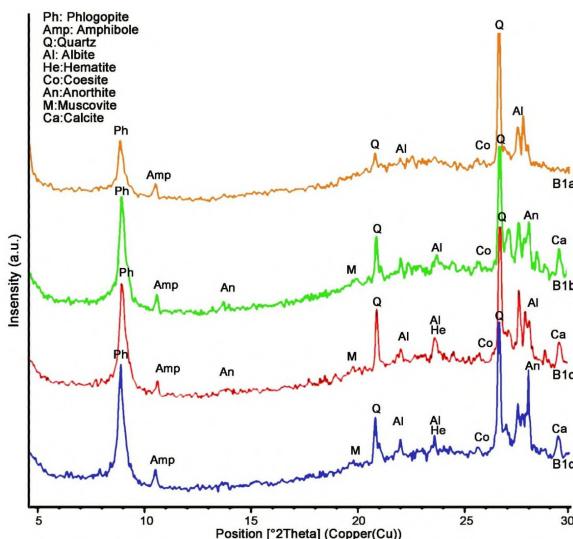
As a result of the XRD analysis of the ethylene glycol-treated four brick samples between 2°-30° (2θ), phlogopite (KMg<sub>3</sub>(AlSi<sub>3</sub>O<sub>10</sub>)(OH)<sub>2</sub>), muscovite (KAl<sub>2</sub>(AlSi<sub>3</sub>O<sub>10</sub>)(OH)<sub>2</sub>), albite (Na(AlSi<sub>3</sub>O<sub>8</sub>)), anorthite (CaAl<sub>2</sub>Si<sub>2</sub>O<sub>8</sub>), quartz (SiO<sub>2</sub>), coesite (SiO<sub>2</sub>), calcite (CaCO<sub>3</sub>), hematite (Fe<sub>2</sub>O<sub>3</sub>) and amphiboles (X<sup>54</sup>,Si<sub>8</sub>O<sub>22</sub>(OH)<sub>2</sub>) peaks were observed, which were shared in F.8. Doyleite (Al(OH)<sub>3</sub>), calcium-silicate-hydrate (CaSi<sub>8</sub>O<sub>24</sub>)<sub>12</sub>H<sub>2</sub>O compounds along with amphibole, quartz, albite, anorthite and muscovite were detected in the mortar samples (Figure 9).

Figure 9: XRD patterns of four different parts of Üç Ayak Church brick (B1)

According to the literature<sup>58</sup>, brick firing temperatures vary between approximately 450 °C and 900 °C. Since coesite was formed in the material, it can be estimated that the Üç Ayak bricks were fired at 700-900 °C. Quartz was not observed in the bricks fired at 1050 °C. Calcite is a carbonate group mineral that starts to appear in fired bricks at 800°C and decomposes at 870°C<sup>59</sup>. It can be inferred that the use of calcium-deficient clays from locally available non-calcareous raw material sources is likely, given the low levels of Ca detected in the composition Table 2. Hematite is produced in non-calcareous bricks at a firing temperature of 850°C, and its presence indicates the temperature at which the bricks were fired<sup>60</sup>. The amphibole peaks indicate the formation of other minerals such as Mg and Na. The relatively small number of these oxides in Table 2 supports this argument. According to these data and the analyzed XRD peaks, the firing temperature of the Üç Ayak Church bricks is estimated to be between 850 °C and 900 °C.

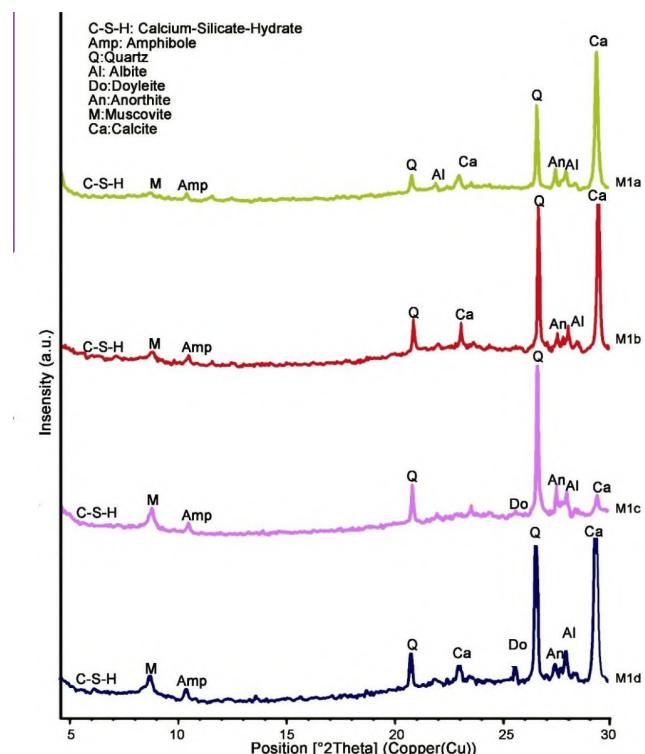
**Figure 10: XRD patterns of four different parts of Üç Ayak Church mortar (M1)**  
Prepared by authors

Doyleite is a rare type of aluminum oxide that is detected weakly in some samples. Although the presence of C-S-H is obviously a significant indication of hydraulicity<sup>61</sup>, the peaks are quite weak. These are sometimes caused by pozzolanic activity at the interface between the brick and mortar. Accordingly, the main materials of the mortar are considered sand and lean lime, which is produced by calcining and slaking limestone that contains 2% to 8% clay<sup>62</sup>.

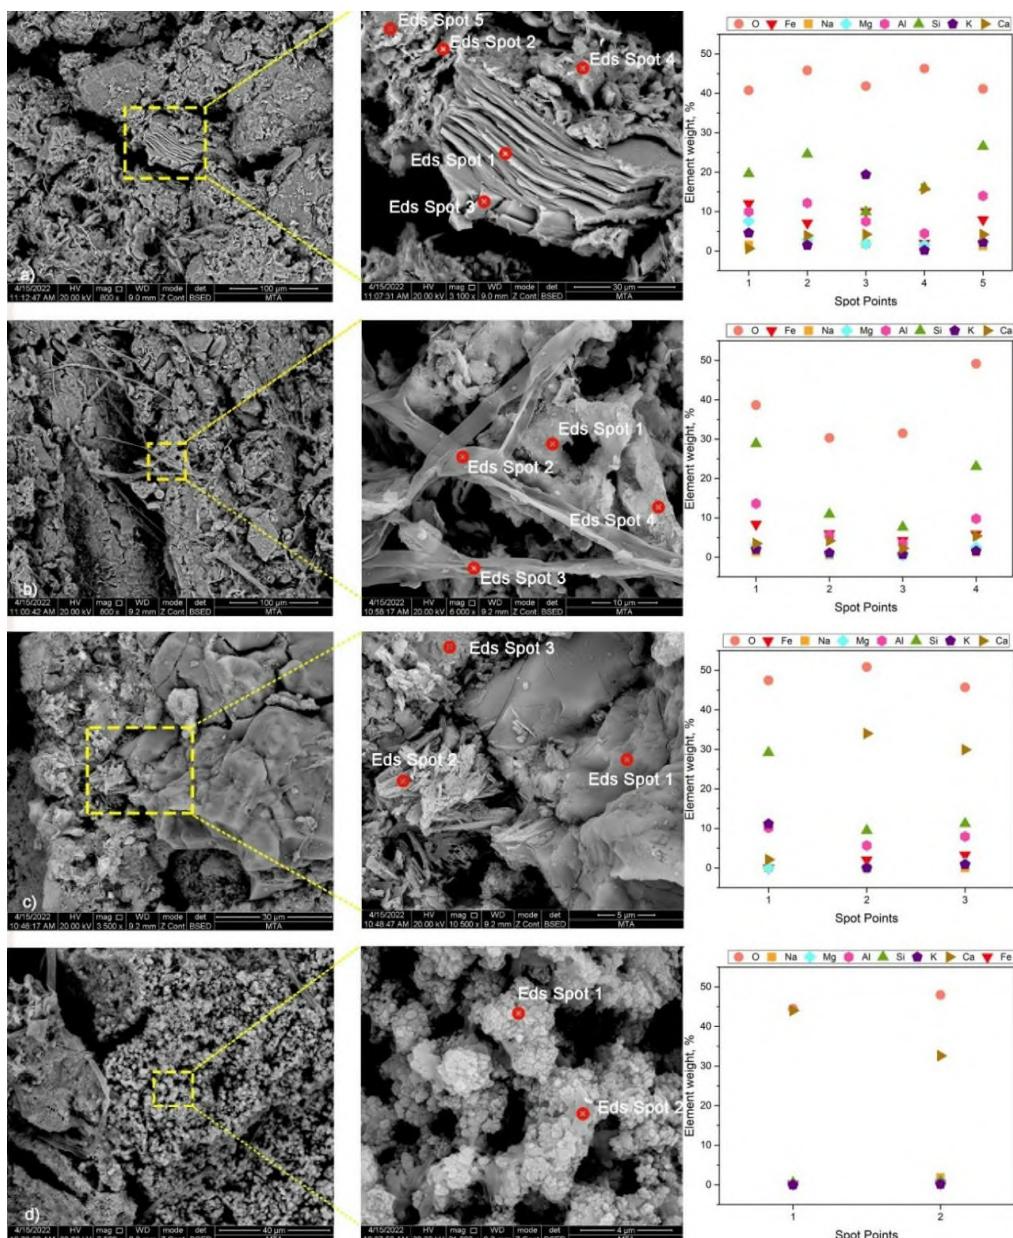
It is anticipated that no vitreous phase is found in the bricks fired between 800 °C and 870°C<sup>63</sup>. The heterogeneous morphology observed in the SEM images serves as evidence that there is no vitreous phase present. The SEM images depicting a partially compact morphology provide further confirmation that the brick was formed at a temperature of 850-900°C, consistent with the XRD phases.

Figure 11: SEM micrographs magnified 800-21.000 $\times$  and EDS spot points along with element weight percentages of the same brick sample from Üç Ayak Church

All EDS spots in (Figure 11a) have a high amount of Si, as expected according to the XRD phases of the Byzantine brick. EDS spot #4 has a high amount of Ca as this area may be an intersection between mortar and brick. Since hematite is also seen in the brick, iron is detected at certain levels in all spots in (Figure 11a). For a vivid red to be seen on the bricks, there must be at least 5% iron<sup>64</sup>. The EDS results clearly show that the observed redness of the Byzantine bricks is due to iron.
